FREETHY DAM

NDI ID NO. PA-00171 DER ID NO. 64-160

PHASE I INSPECTION REPORT

NATIONAL DAM INSPECTION PROGRAM

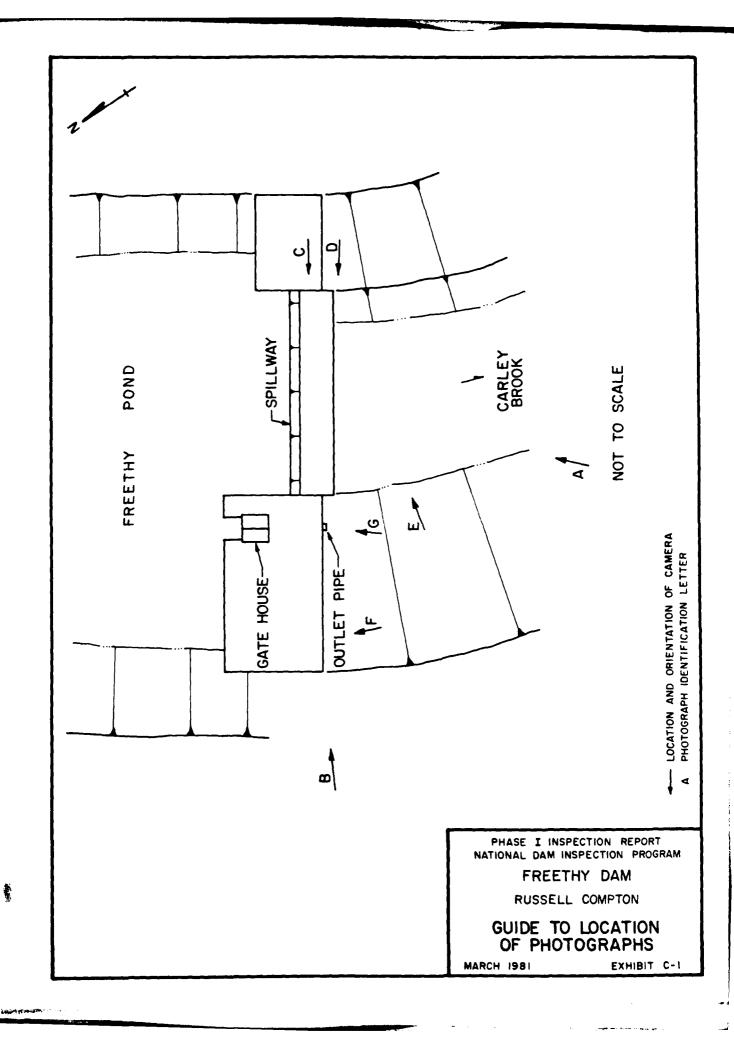
H. Downstream Channel.

e. Downstream Conditions. A stone masonry, horseshoe-shaped road culvert, 24 feet high, is located approximately 150 feet downstream from Freethy Dam. The stream channel downstream from the culvert is deep and steeply sloping. The streambed is composed of gray shale. Erosion patterns in the shale indicate that the rock is of variable hardness. Several apartment buildings and at least 5 houses are located along the stream channel between the dam and the Lackawaxen River located approximately 1,500 feet downstream. It is likely that several of these residences would be flooded in the event of a dam failure, possibly resulting in the loss of three or more lives. Accordingly, a high hazard classification has been assigned to Freethy Dam.
